# Manhole Inspection Summary

Manhole # S41CC\_020MH

Insp Date: **11/25/08 9:45 AM**

**Location** Address: **910 n caroline st**

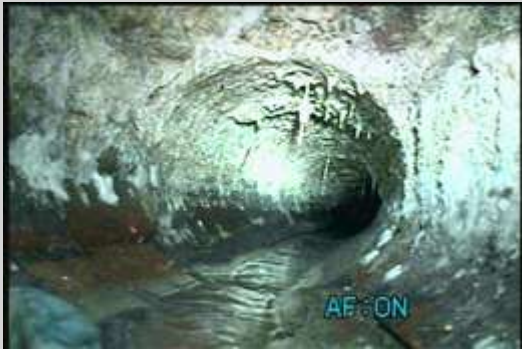
12 O'Clock Outflow

8 in. Circular Gravity Sewer  
Pipe Out @ 12 O'Clock

Invert Depth: **9.41** (ft.) Flow Characteristics: **Slow**

Infiltration: **None** Pipe Seal Cond: **Unknown**

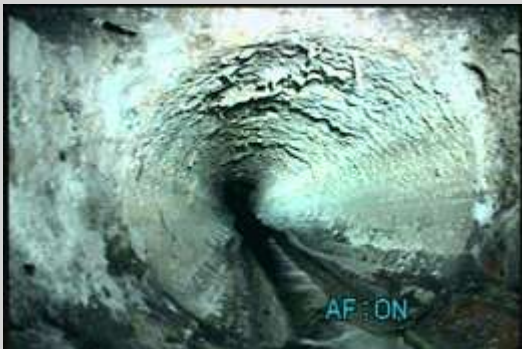
5 O'Clock Inflow

8 in. Circular Gravity Sewer  
Pipe In @ 5 O'Clock

Infiltration: **None** Pipe Seal Cond: **Unknown**
